Plan View of Stream Segment 1

Interim Stormwater Hydrology and Hydraulics Report for Lower Little Salt Creek Watershed

Stream Segment 1 in Little Salt Creek

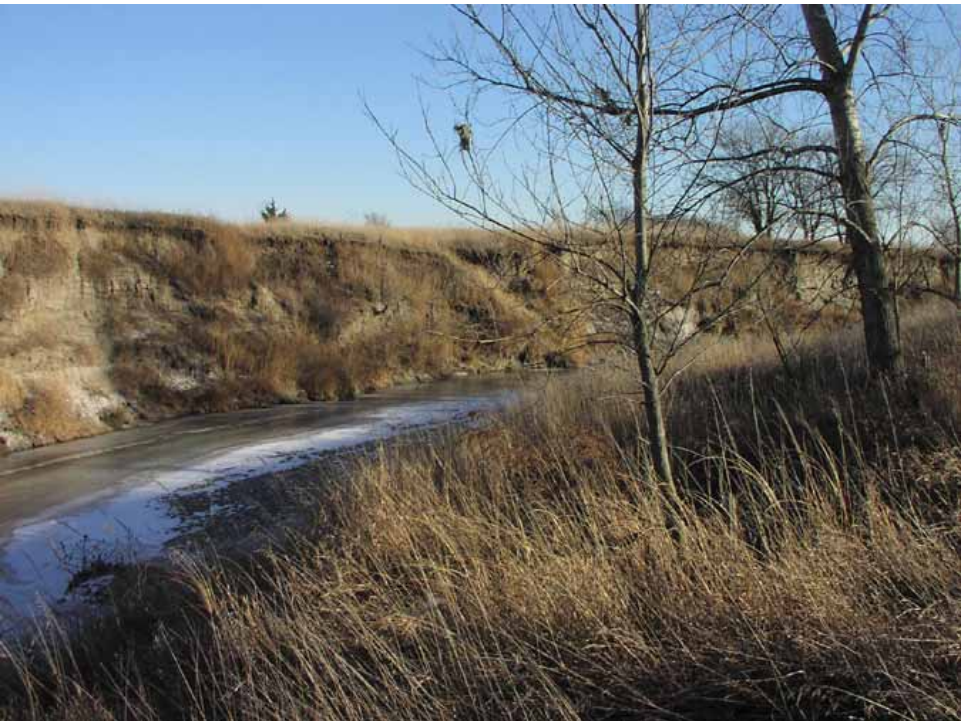
Photo 1: Looking downstream from Interstate 80.

This reach shows signs of active streambed and bank erosion. The predominant factor causing this erosion is head cutting that is proceeding upstream from Salt Creek. The channel has incised 15 to 20 ft below its historic level based on evaluation of adjacent oxbows.
- Flood Hazard

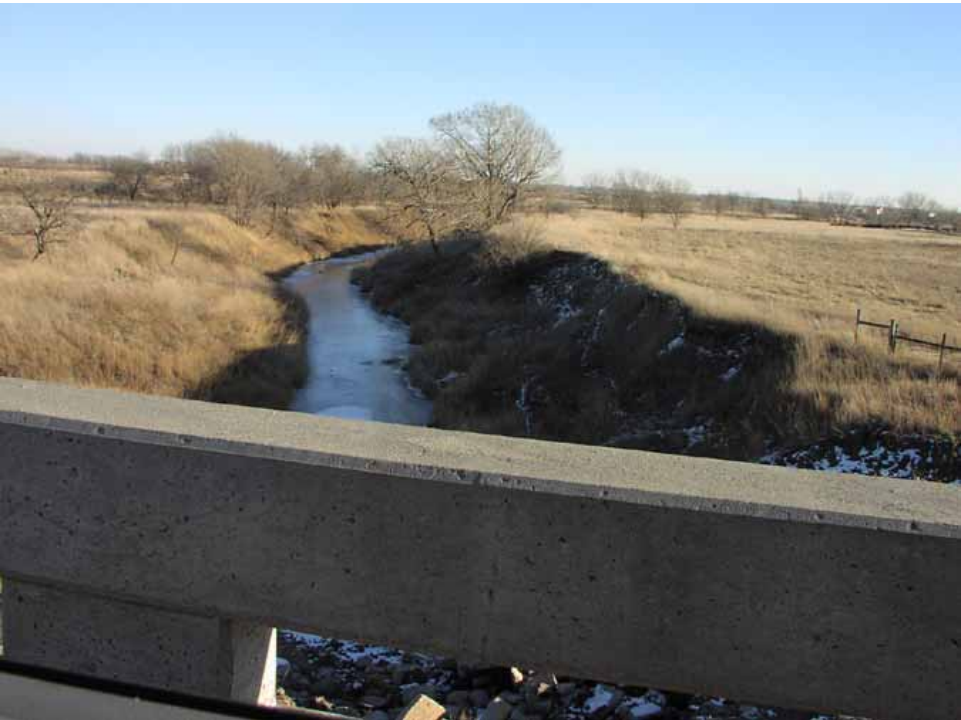
Photo 2: Looking at the east channel bank.

Active channel bank sloughing can be observed along the whole segment. There is no immediate threat apparent to overhead or buried utilities. The roadway crossings at the Interstate exceed DCM requirements for overtopping (see the hydraulics section for more information on overtopping frequency).
- Water Quality

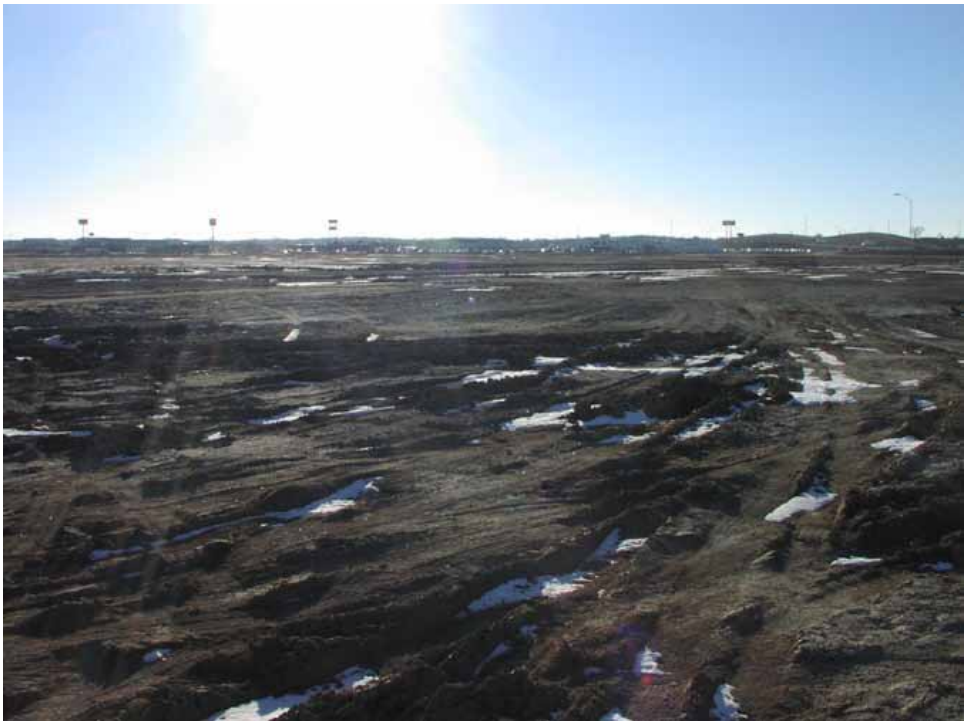
Photo 3: Looking west at fill.

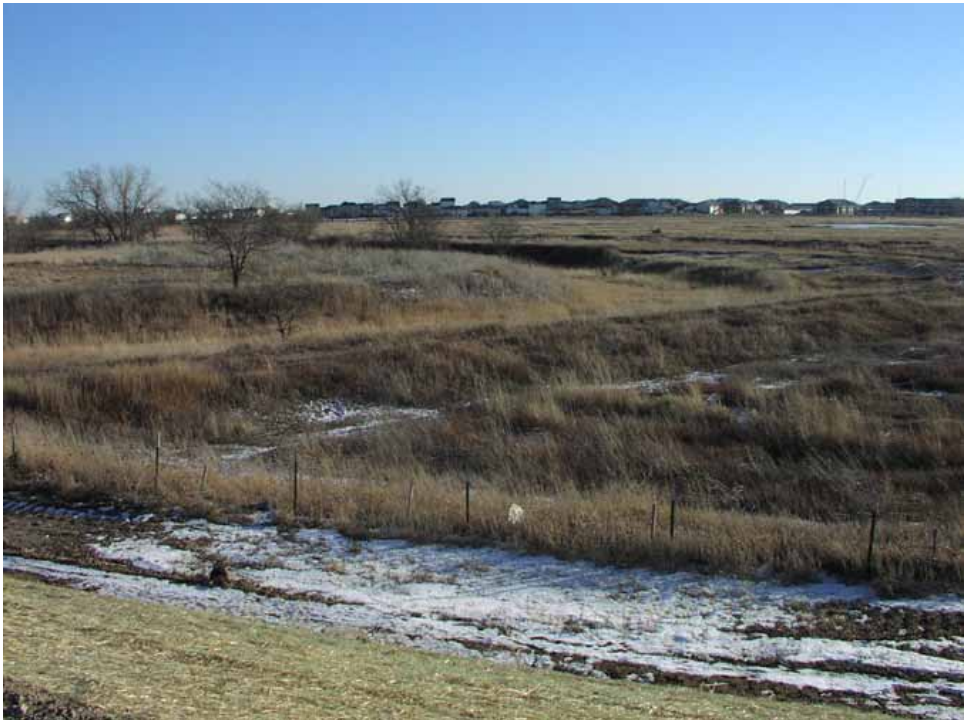
Photo 4: Looking south at old oxbow.

- Reach Stability This reach shows signs of active streambed and bank erosion. The predominant factor causing this erosion is head cutting that is proceeding upstream from Little Salt Creek.

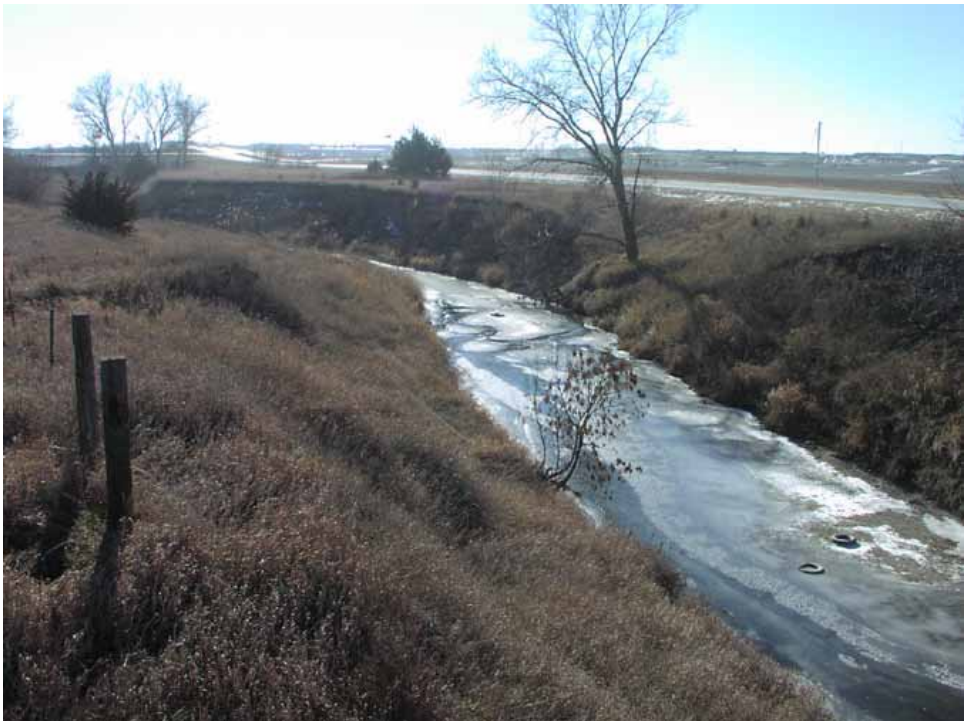
Photo 5: Looking downstream from Arbor Road bridge.

- Reach Stability This reach shows signs of active streambed and bank erosion. The predominant factor causing this erosion is head cutting that is proceeding upstream from Salt Creek.

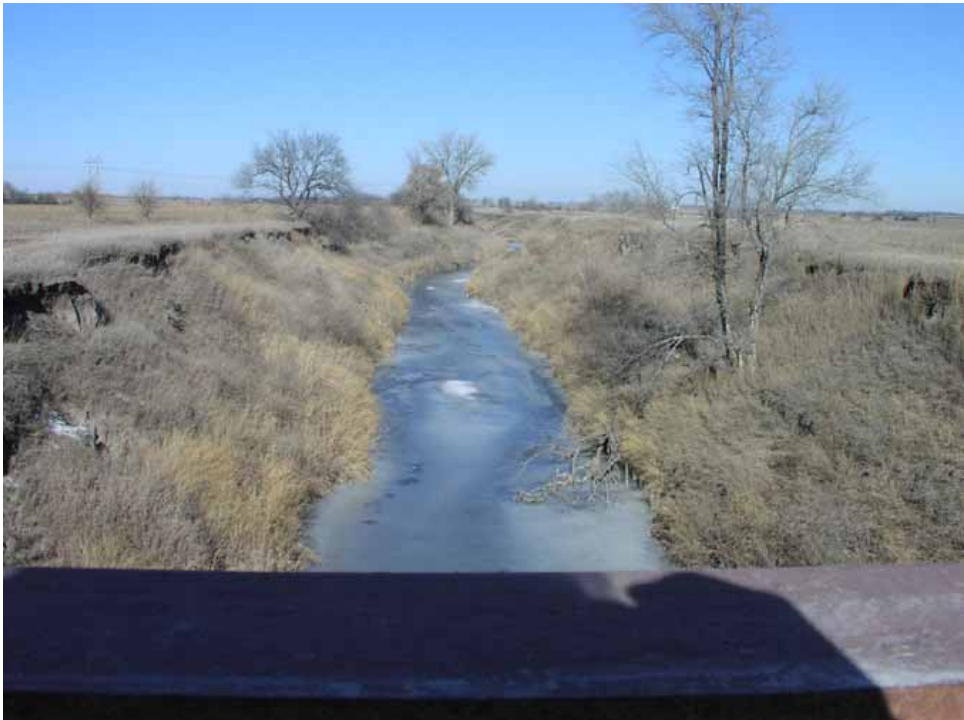
Photo 6: Looking upstream from Arbor Road bridge.

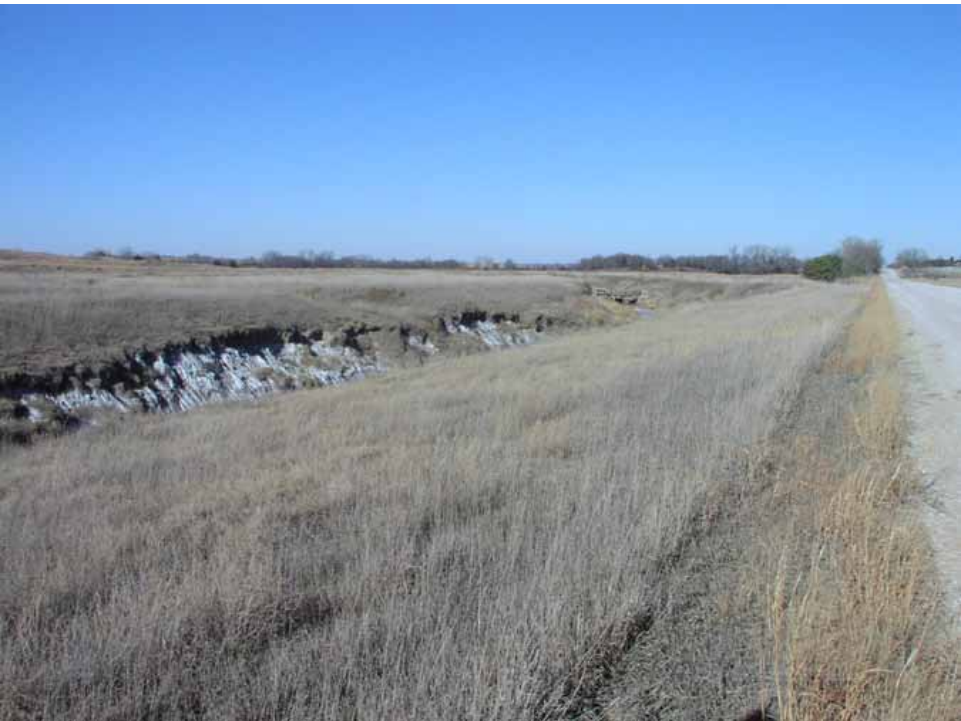
Photo 7: Looking upstream from private driveway.

This reach shows signs of active stream bed and bank erosion. Broken concrete riprap was placed along the west bank in an attempt to stabilize the toe. Unfortunately, doing so buried prime habitat for the Salt Creek Tiger Beetle.
- Flood Hazard

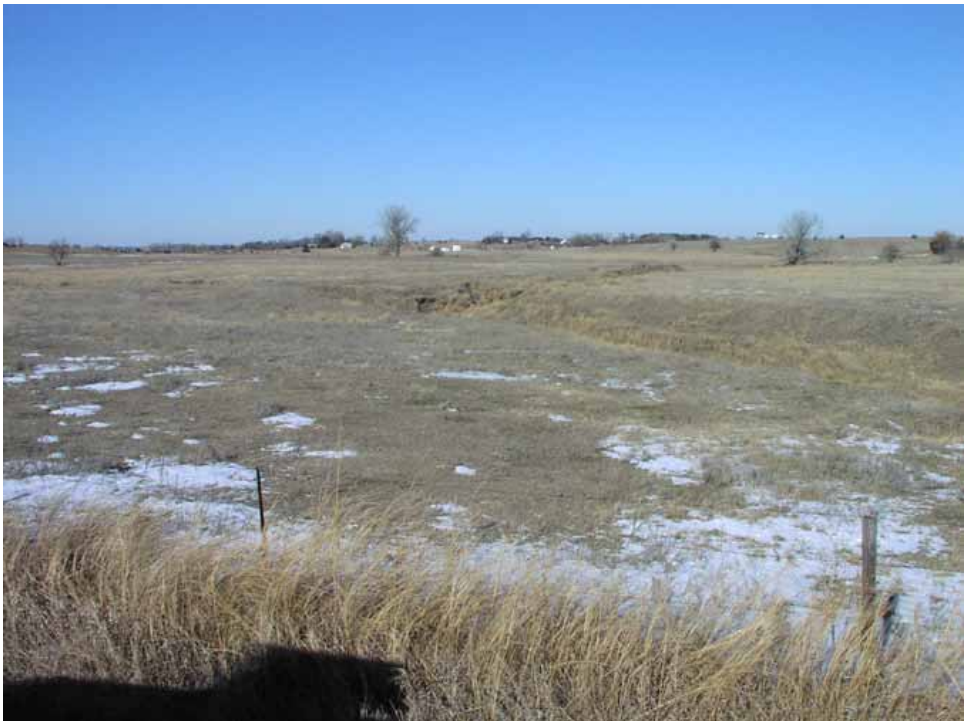
Photo 8: Looking downstream from Waverly Road.

- Reach Stability This reach shows few signs of active stream bed and bank erosion. The channel has a moderate degree of meanders.
- Flood Hazard Pasture and wetlands along the channel are subject to flood hazard. No buildings appear to be within the limits of the 100-year floodplain.

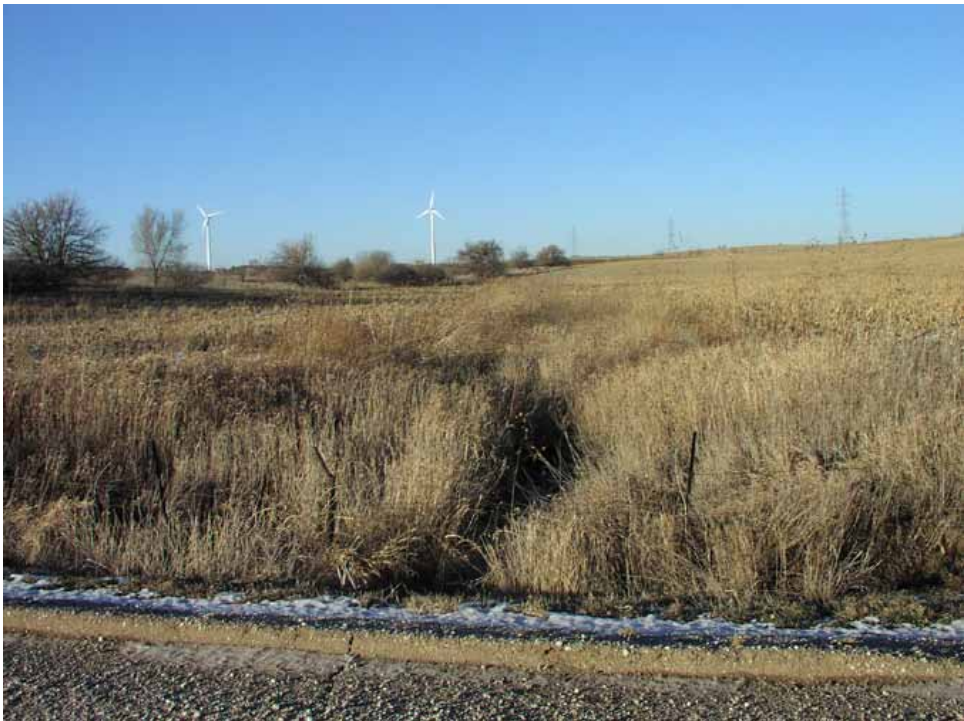
Photo 9: Looking upstream from Arbor Road.

- Reach Stability The stream segment in this basin has been modified by agricultural development between Interstate 80 and Arbor Road. The culvert at Arbor Road serves as a hard point for the channel.

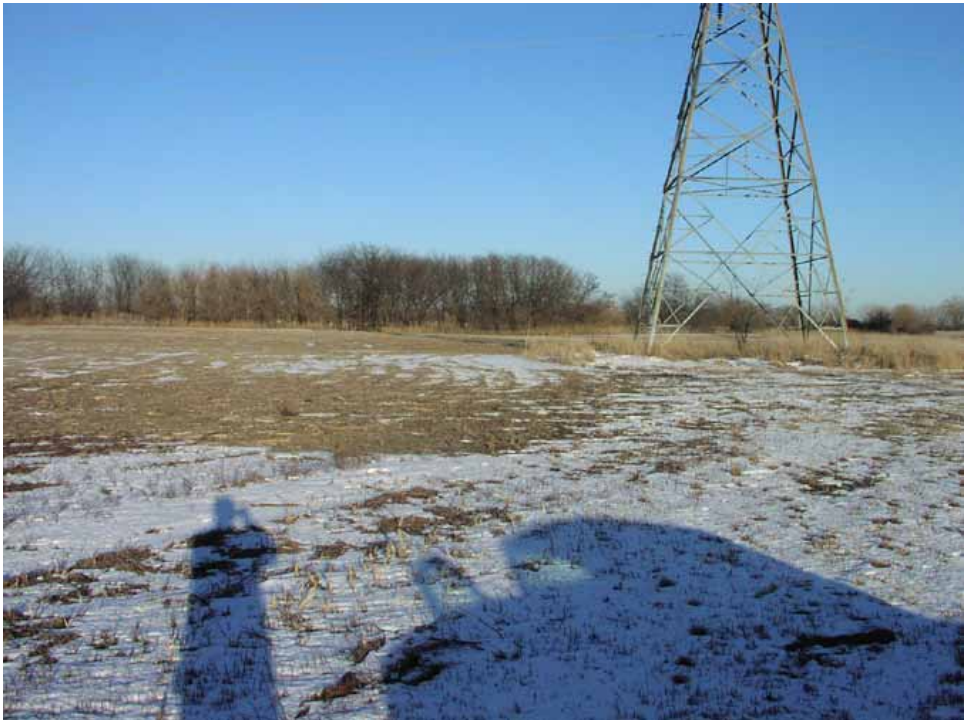
Photo 10: Looking easterly toward Salt Creek.

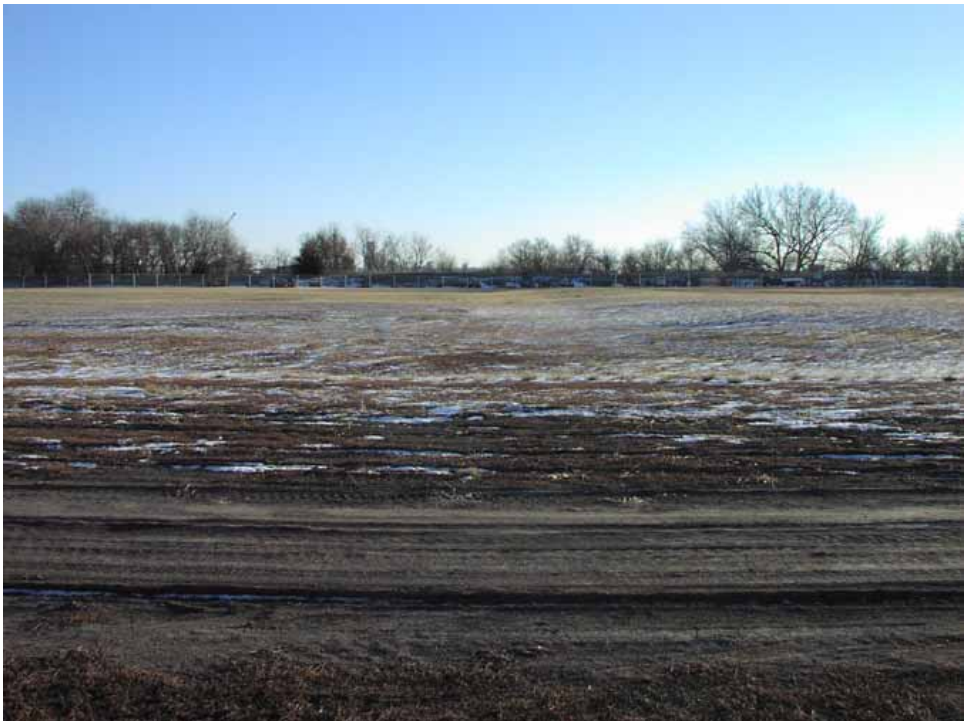
Photo 11: Looking downstream toward Salt Creek.

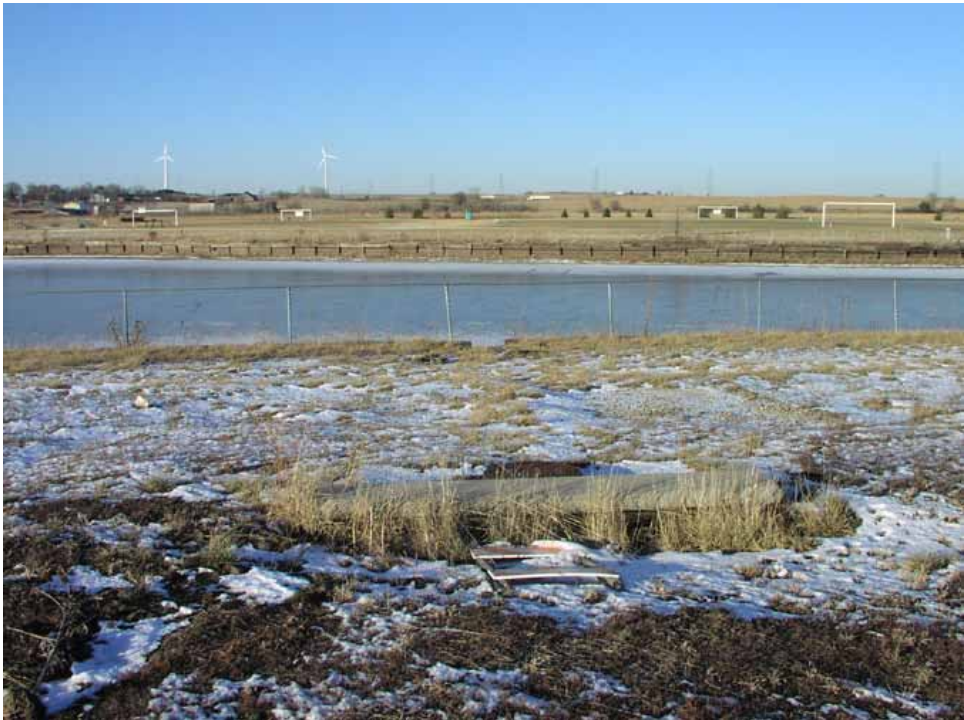
Photo 12: Looking upstream at detention pond.

- Reach Stability The runoff from this subbasin is temporarily stored in a detention pond and released into Salt Creek.
- Flood Hazard The buildings appear to be above the 100-year floodplain. The sports fields and internal roads are subject to flood hazard. Plans call for construction of additional sports fields and supporting infrastructure. Some of the proposed improvements would need to meet “no-rise” regulations for development in the floodway.

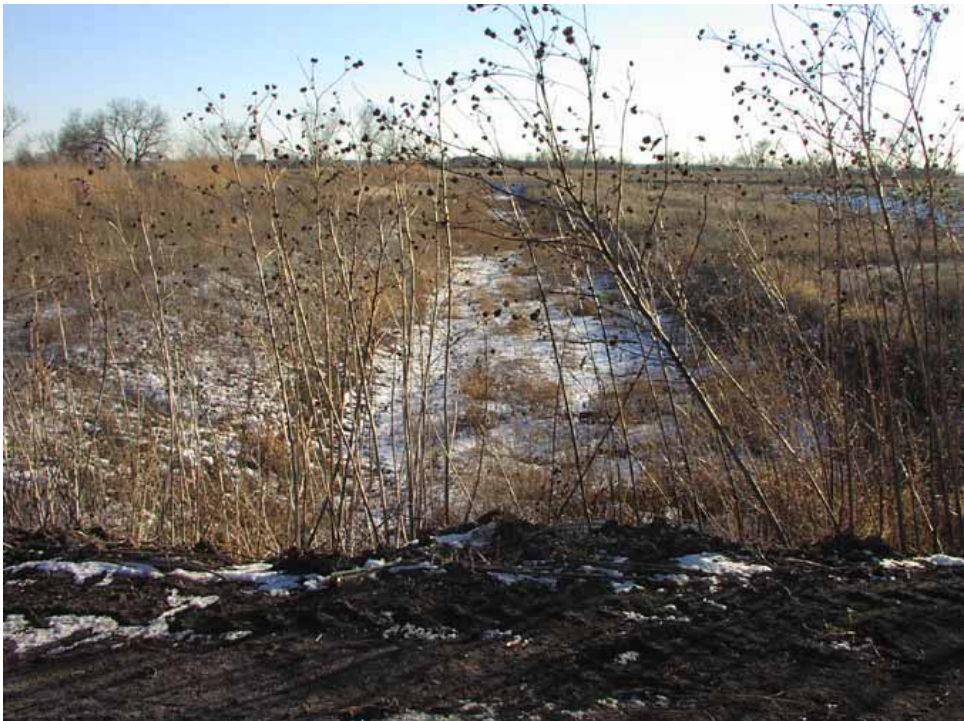
Photo 13: Looking downstream toward Salt Creek.

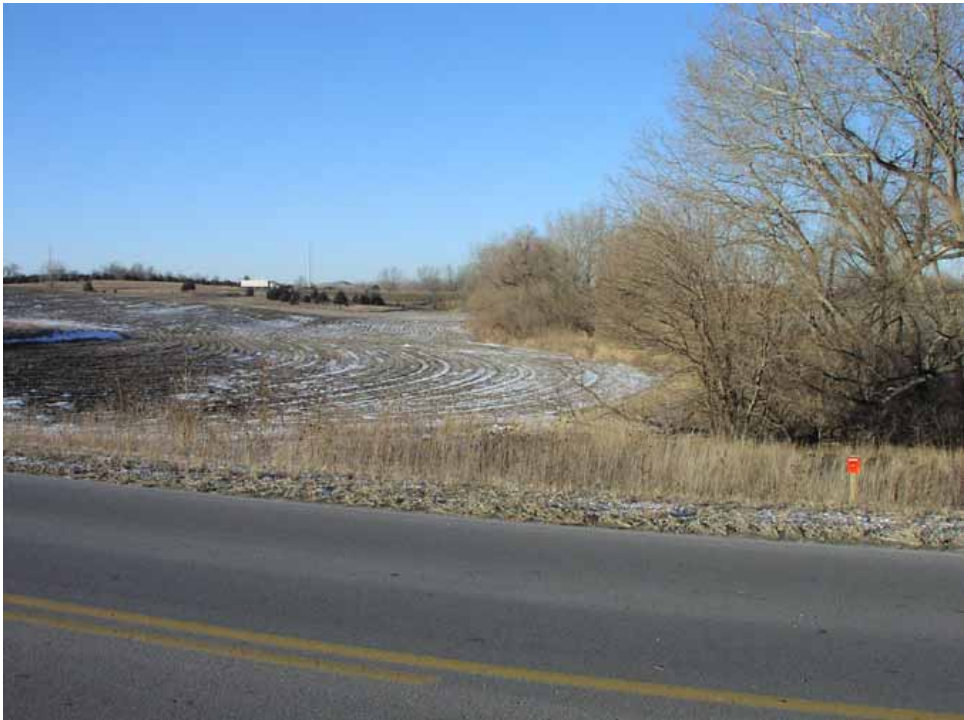
Photo 14: Looking upstream toward Interstate 80 from Arbor Road.

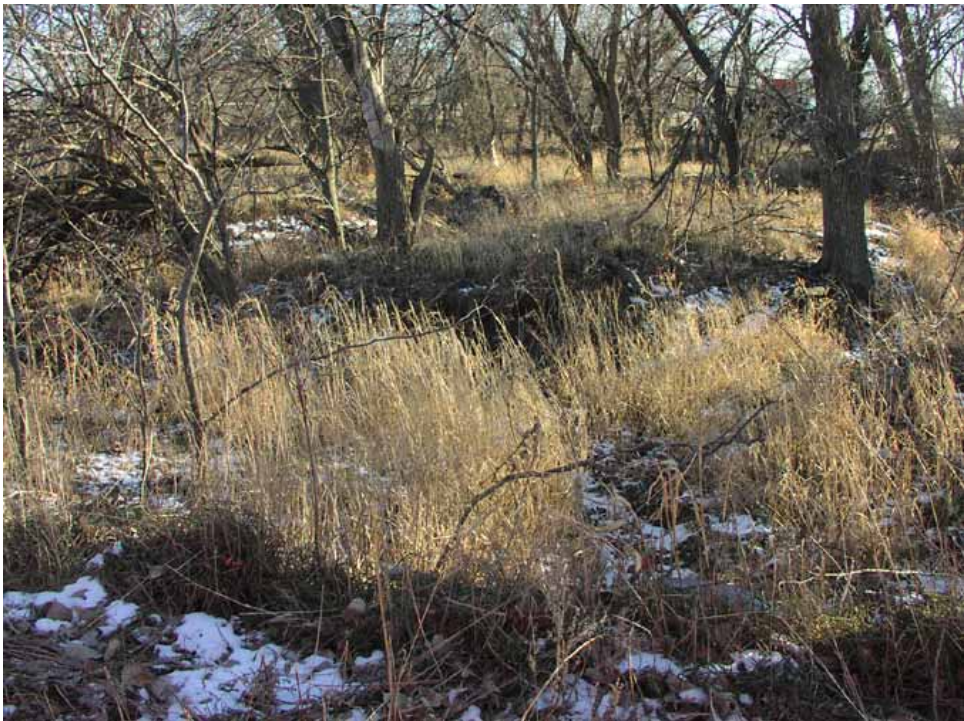
Photo 15: Looking downstream at Salt Creek.

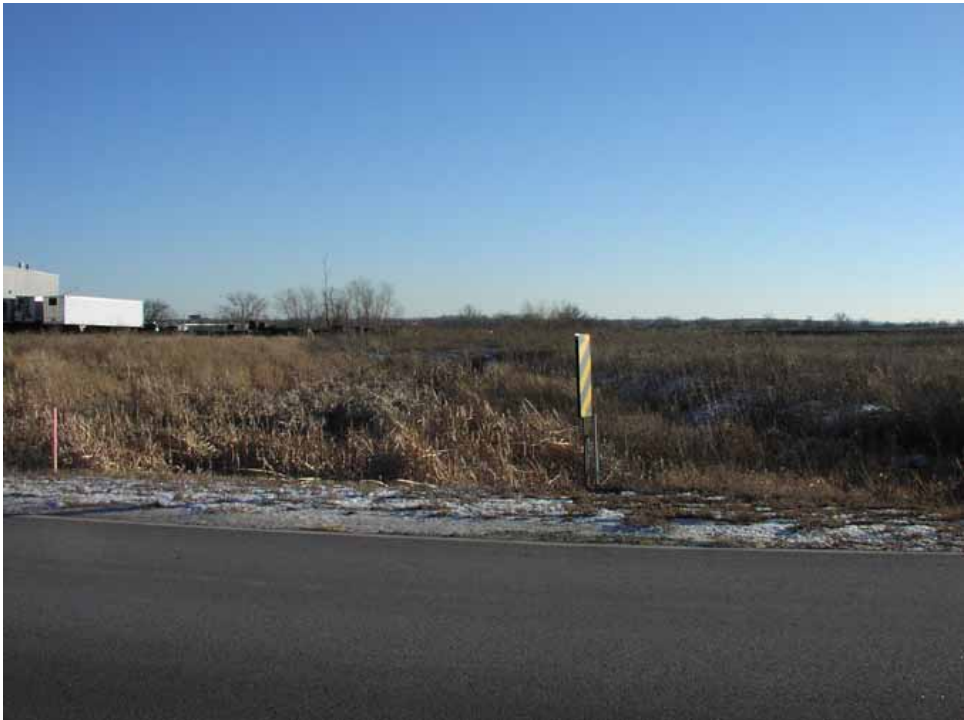
Photo 16: Looking downstream from Arbor Road.

- Flood Hazard A Corrugated Metal Pipe (CMP) storm drain conduit has been installed in the channel north of Arbor Road. It appears to be severely undersized, increasing the flood hazard to any future buildings constructed on the site. No existing buildings appear to be within the limits of the 100-year floodplain.

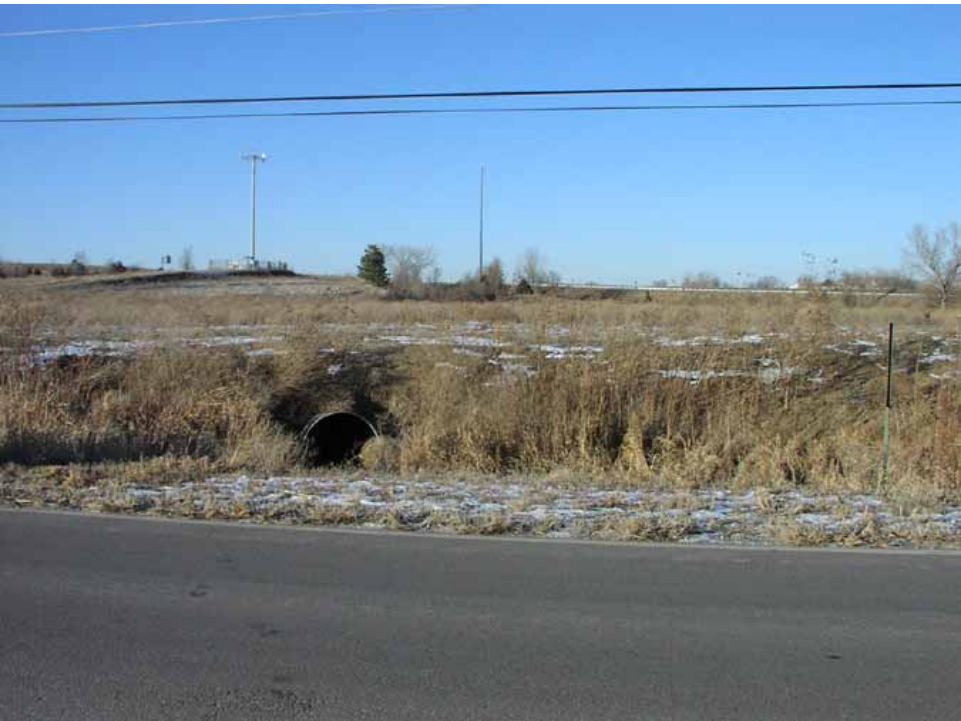
Photo 17: Looking upstream from Arbor Road at the CMP culvert.

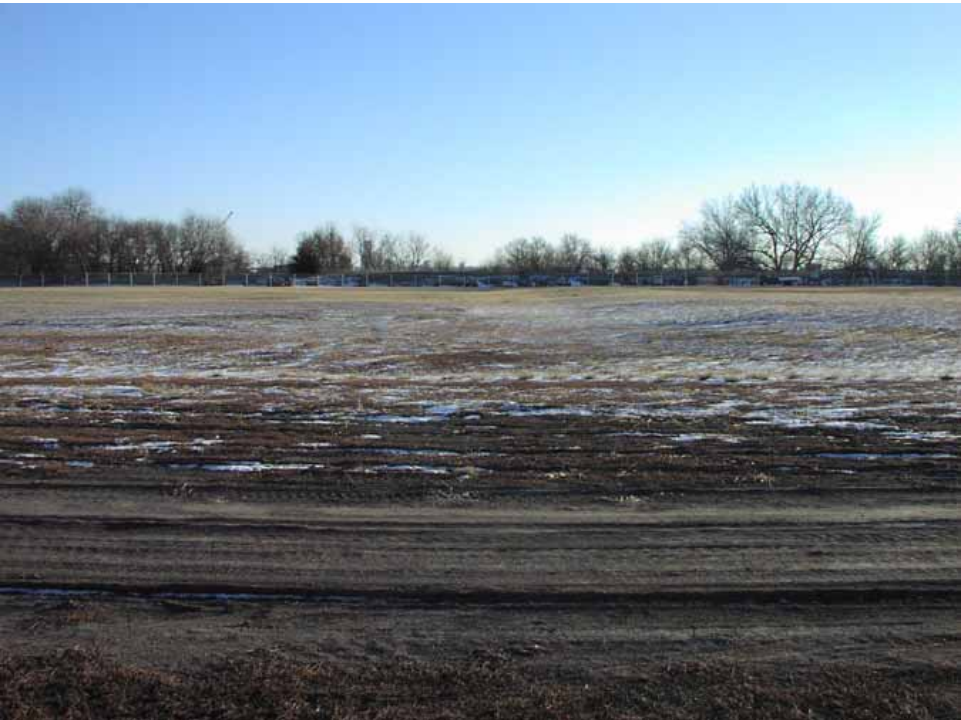
Photo 18: Looking downstream from 56th Street.

- Flood Hazard Flows will overtop the intersection of the Interstate 80 west-bound off-ramp and Highway 77. These flows will likely cause ponding underneath the Interstate 80 interchange. No existing buildings appear to be within the limits of the 100-year floodplain.

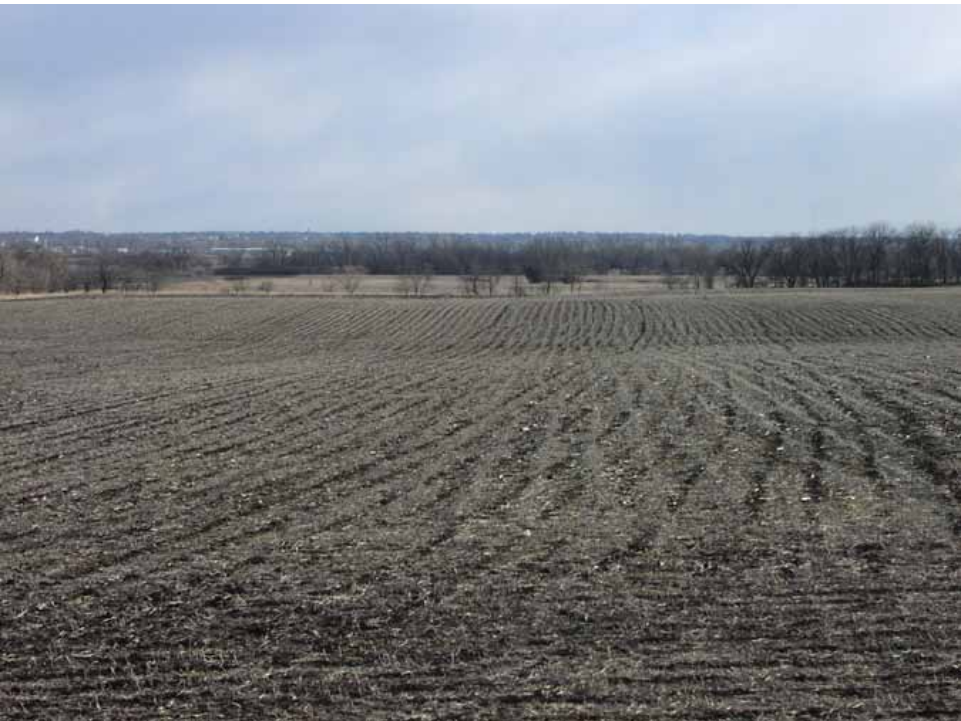
Photo 19: Looking toward Salt Creek from Arbor Road.

- Reach Stability The watershed discharges into freshwater and saline wetlands and then outlets into Salt Creek.
- Flood Hazard The area adjacent to the stream is crop and pasture land. Commodity crops and pasture along the channel are subject to flood hazard. No buildings appear to be within the limits of the delineated Salt Creek floodplain.

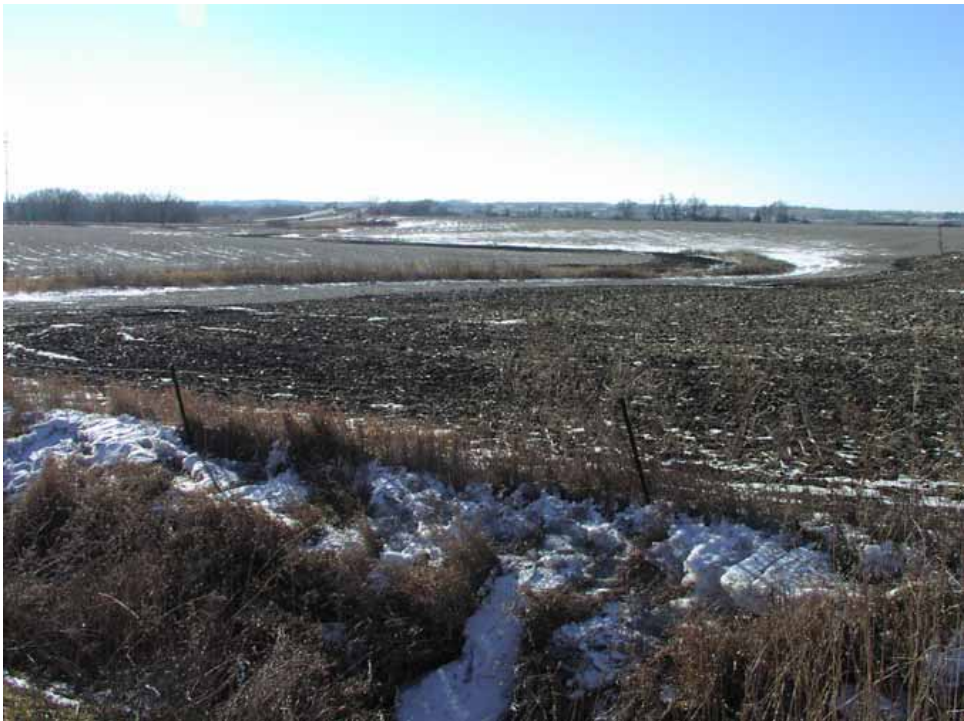
Photo 20: Looking downstream from North 40th Street.

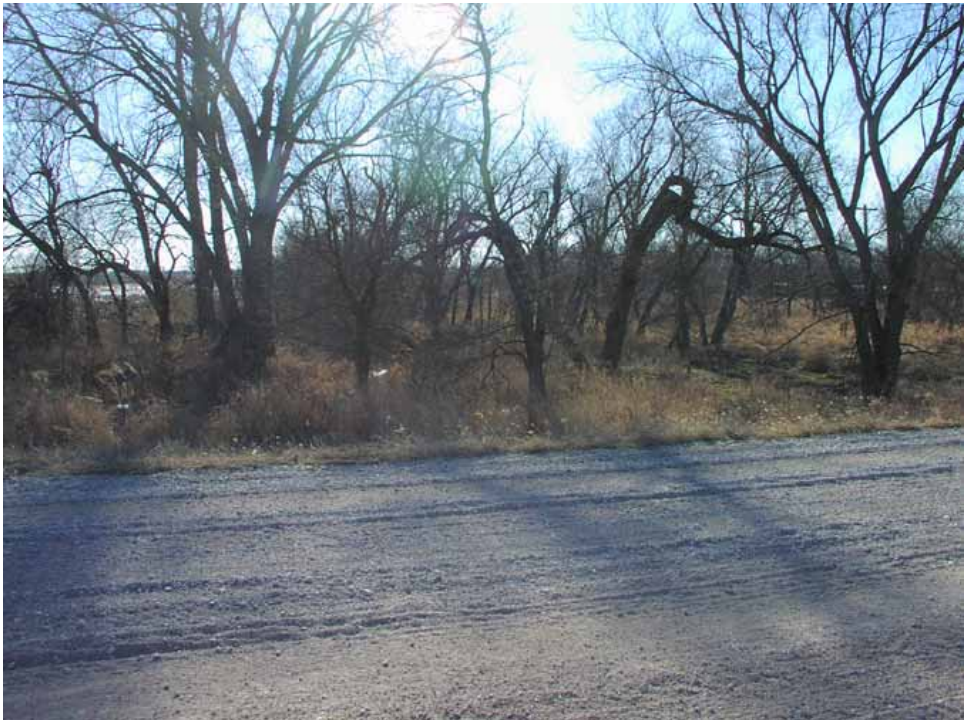
Photo 21: Looking downstream from Arbor Road.

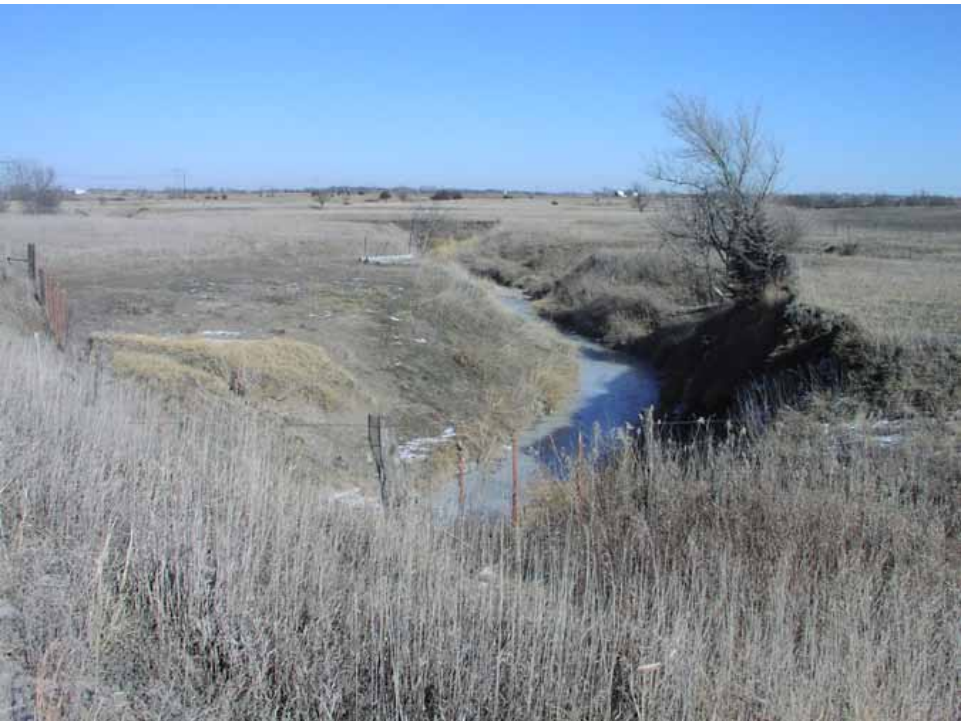
Photo 22: Looking upstream from North 27th Street along mainstem.

- Reach Stability This reach shows signs of active stream bed and bank erosion. The predominant factor causing this erosion is head cutting that is proceeding upstream from Little Salt Creek. The culvert at North 27th Street serves as a hard point in the channel. There is some evidence of head cutting upstream of the culvert. The abandoned Chicago/Northwest Railroad grade causes a restriction in the channel, resulting in locally erosive velocities.

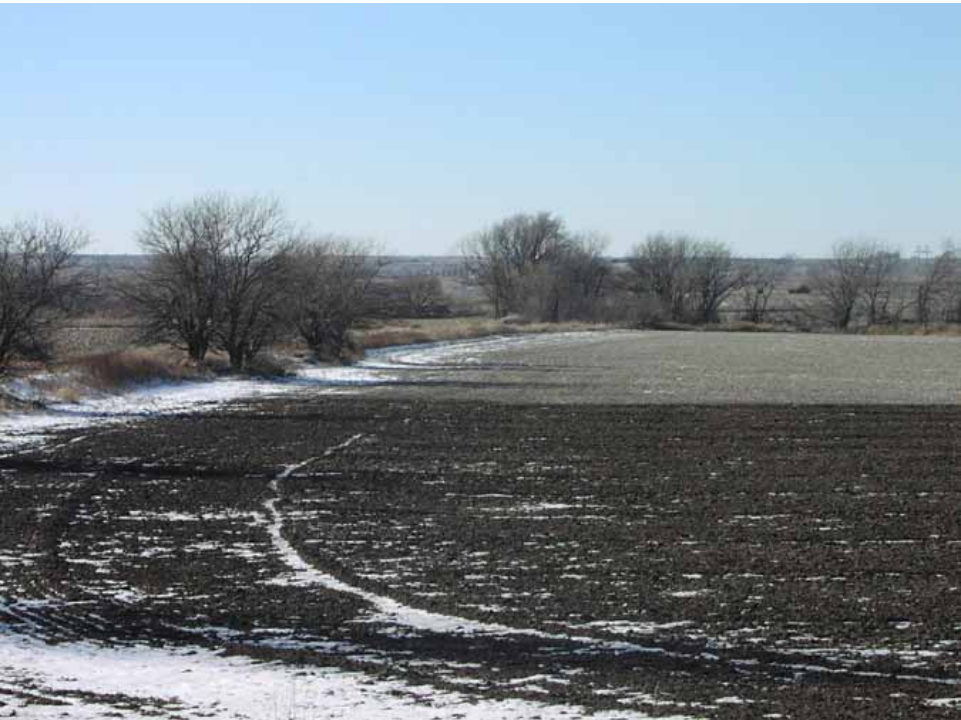
Photo 23: Looking downstream from North 40th Street at upper reach.
